Uretara

Sub-Catchment Action Plan 2012

The Uretara Sub-Catchment Action Plan is one of a series about the sub-catchments surrounding Tauranga Harbour. This action plan provides an analysis of the current land management issues, a summary of the available physical resources in the Uretara sub-catchment, and planned action for land and resource use in the sub-catchment.

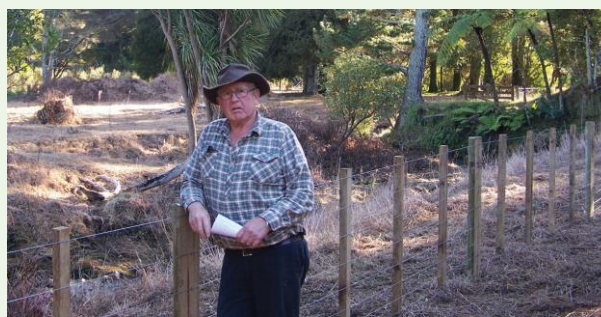
Alister Harvey in front the Quarry Stream with Kahikatea stand in the distance. Fencing has been completed and the site recently sprayed ready for planting.

The project involves fencing a 120m stretch of the stream and planting the banks and floodplain with native trees and sedges. This treatment will improve the stream habitat and water quality by lowering water temperatures through shading, intercepting nutrients and sediment, and stabilising stream banks.
